# Compliance Test of X-Ray Beam Quality Using HVL Parameter on Digital Mammography

## Abstract

The compliance test of X-ray beam quality using HVL parameter on digital mammography was determined at a hospital in Makassar in 2019-2021. This measurement uses a ruler, X-ray multimeter, and aluminum filter. The exposure process is carried out at certain kVp and mAs conditions after placing the detector on the examination table. The HVL test to determine the X-ray beam quality is carried out by placing the detector 4 cm from the edge of the chest wall on the patient's table in an upright position facing the tube. The resulting HVL values are 0.37, 0.37, and 0.38. This study resulted in a p-value of 0.000 ( $p < 0.05$ ). Statistically, there is a significant difference in HVL values in 2019-2021. The resulting HVL value is by the tolerance limit recommended by the IAEA, which is  $0.31 \leq \text{HVL} \leq 0.58$ . These values indicate that mammography works well, and it is safe for the patient.

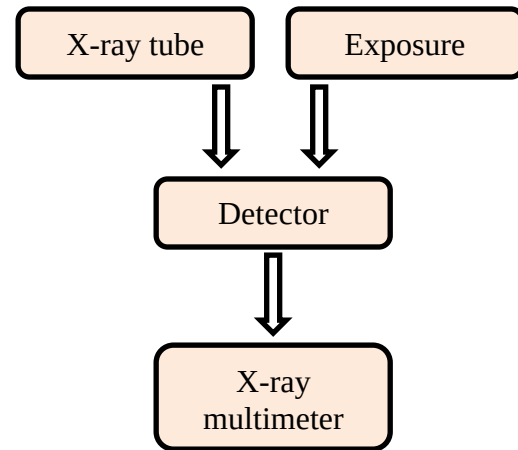
This study used a GE digital mammography machine, the Senographe Crystal type on the tube housing, and the generator/control panel SHF-0510-M with a maximum capacity of 35 kVp and 320 mAs. The compliance test using the HVL parameter was carried out at the Radiology Installation of one of the leading hospitals in Makassar in 2019-2021. This measurement's tools and materials are a ruler, X-ray multimeter, and aluminum filter. The scheme for testing the suitability of the quality of the X-ray beam is shown in Figure 1.

**Figure 1.** Schematic of compliance test on digital mammography.

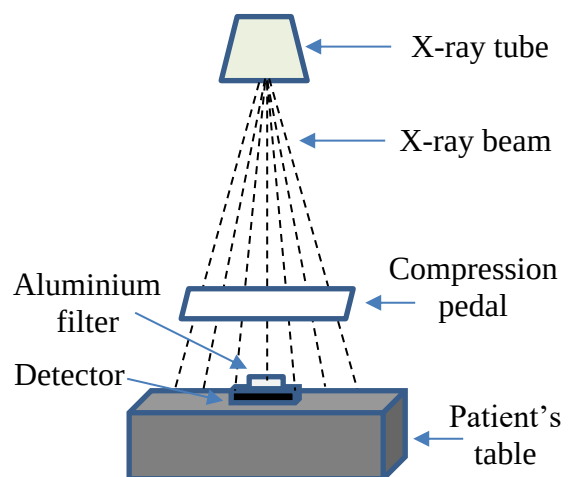
The exposure process is carried out at certain kVp and mAs conditions after the detector is placed on the examination table to measure the X-ray beam quality parameters, as shown in Figure 2.

**Figure 2.** Measurement of X-ray beam quality.

The HVL test to determine the quality of the X-ray was carried out by placing the detector 4 cm from the edge of the chest wall on the patient's table in an upright position facing the tube (Figure 2). The exposure process was carried out at fixed mAs and kVp. The air kerma value is measured without an additional filter ( $D_0$ ). An aluminum filter was added to the exposure process, which resulted in more than half the  $D_0$  dose being carried out

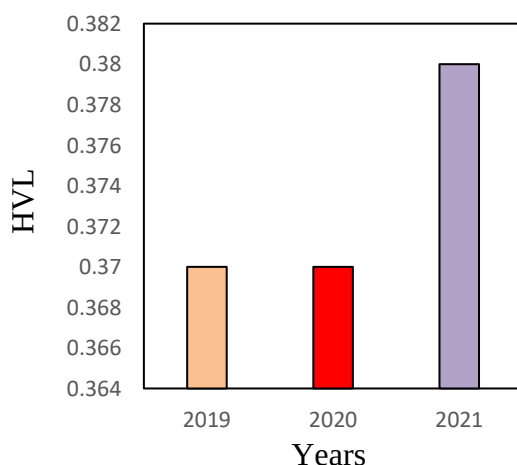
The HVL parameter compliance test results using 2019-2021 data are shown in Figure 3.

**Figure 3.** Graph of HVL parameter compliance test from 2019-2021.

Figure 3 shows the HVL values 2019-2021, resulting in values between 0.37,

0.37, and 0.38. These values indicate the quality of the X-ray beam expressed in terms of HVL. The penetrating power of X-rays measures the quality of the X-ray beam through which the object is passing through. The quality of X-ray is influenced by the tube voltage [17]. The HVL values 2019-2021 can be seen in Table 1.

The HVL test results were processed in the SPSS application using a one-sample test to determine the significance of the test results. This test is marked from the resulting p-value. This study resulted in a p-value of 0.000 ( $p < 0.05$ ). Statistically, there is a significant difference in HVL values in 2019-2021. Table 1 shows the HVL values of 0.37, 0.37, and 0.38. This value is close to the value reported by Pwamang, et al [15]. In addition, these HVL values are by the tolerance limit recommended by the IAEA, which is  $0.31 \leq HVL \leq 0.58$  [18]. The values in Table 1 show that mammography works well, and it is safe for the patient.
